Scope of the Assessment

Rapid Assessment Teamwork

Major Assessment Findings with their severity

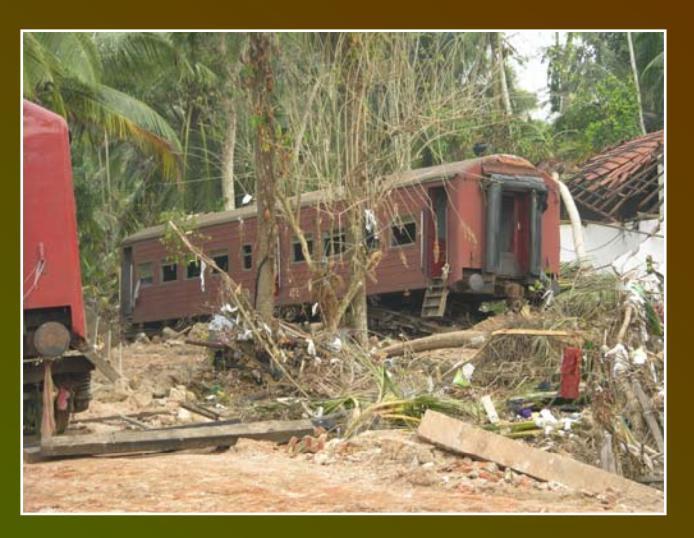
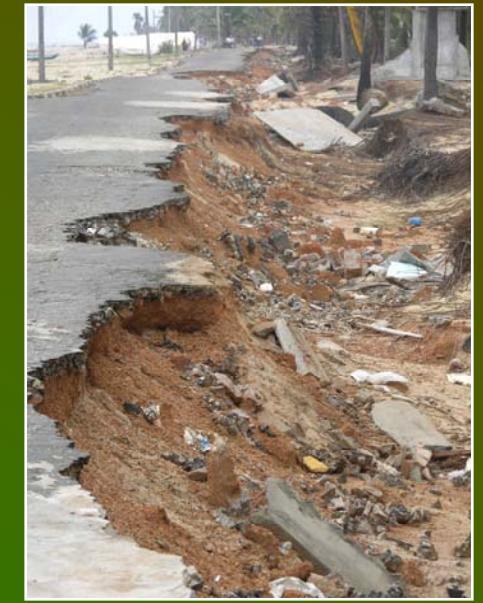
Variation in depth of penetration

- The waves were up to 9 m high, and penetrated inland for up to 3 km
- The median depth of penetration was about 300 m in Trincomalee and Ampara, 130 m in Batticaloa, 110 m in Matara, 100 m in Hambantota, 70 m in Galle, and 50 m in Jaffna

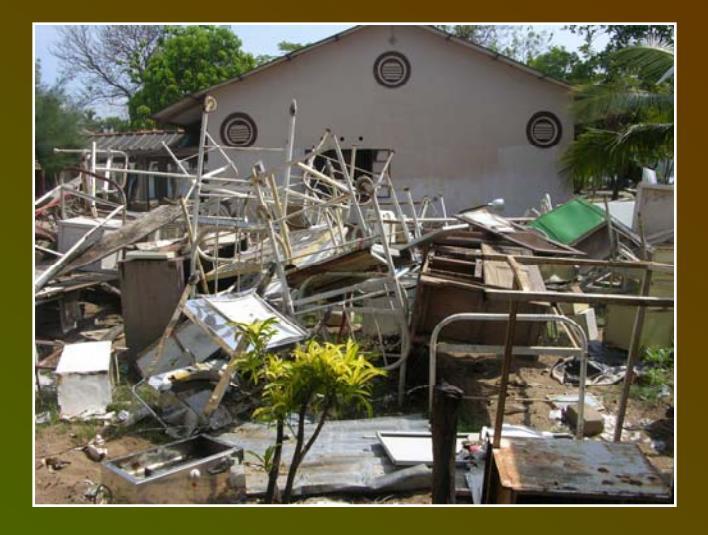
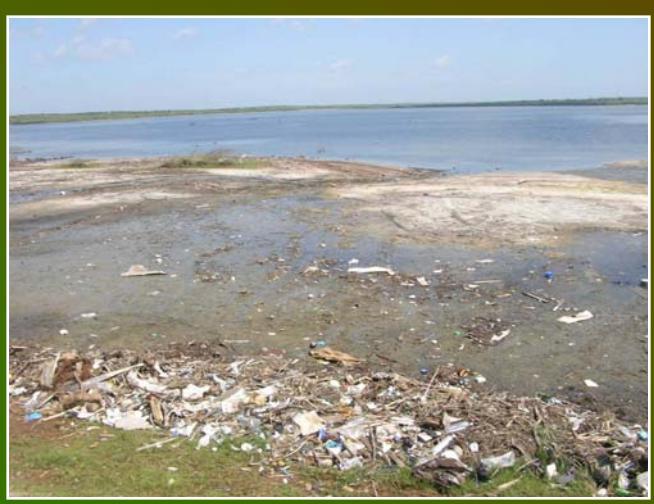
Debris and solid waste

- Over 500 million kg of rubble

an enormous challenge to the solid waste management system
- Debris and sand, from the tsunami or clean-up operations, block drainage channels in many areas, posing a risk of waterlogging, loss of farmland, and increased mosquitoborne disease
- Little blackish sludge from coastal areas

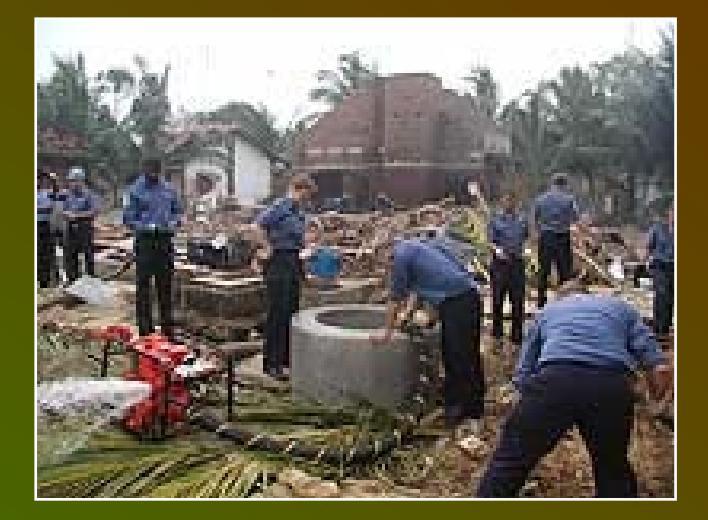
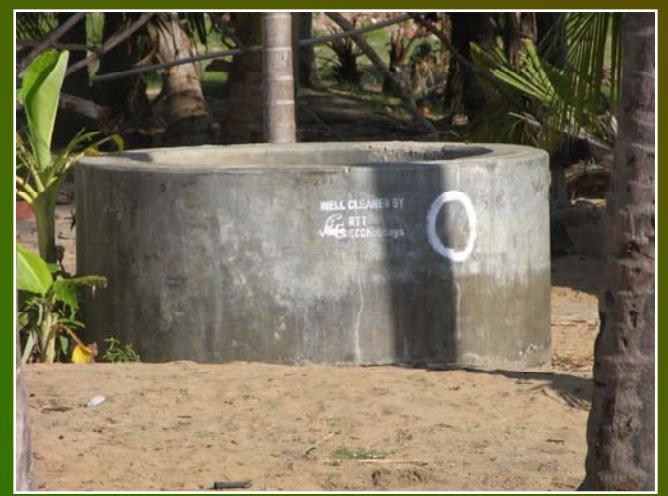
Salinization of drinking water wells

- Salinization has made more than 15,000 wells unusable for drinking water supplies
- Over-pumping of wells in an attempt to clean out contaminated water has often encouraged saltintrusion, which has done more harm than good

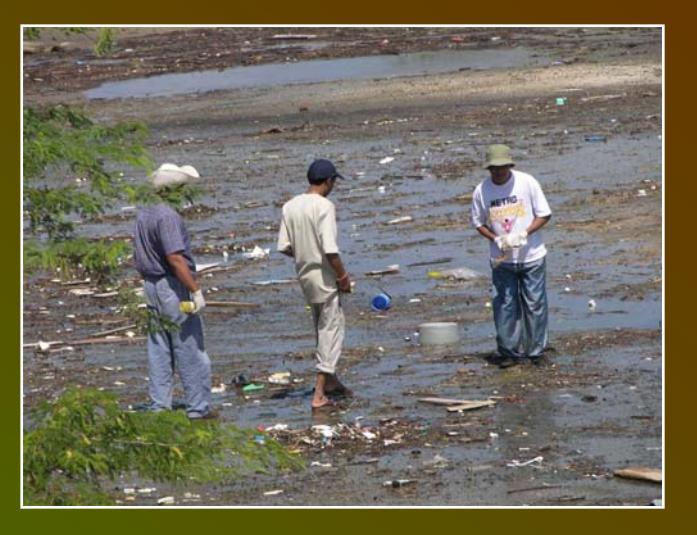
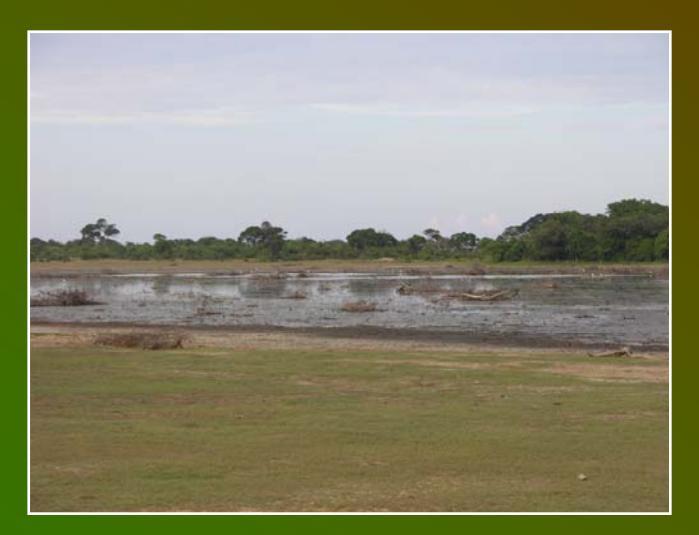
Contamination of water bodies

- Many coastal water bodies have been contaminated with salt-water, debris, and sludge - eg Karagan lewaya, Sastarawila in Panama etc.
- Some have also become stagnant, anoxic and dead from lack of oxygen and purification
- Some water bodies to cause chronic impacts and others to cause acute impacts

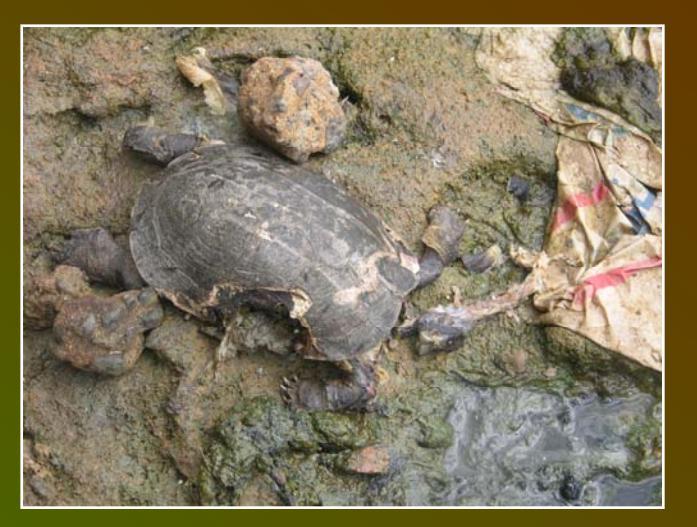
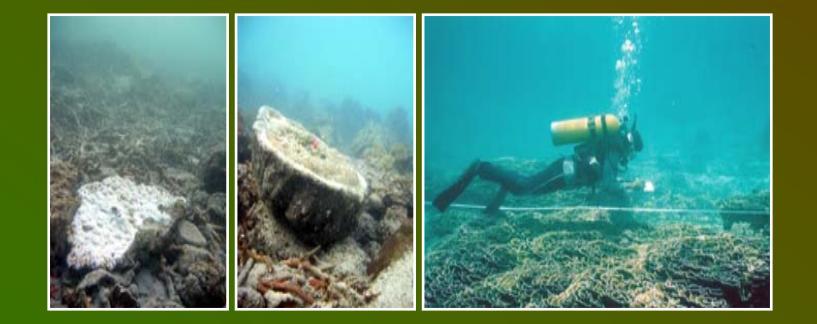
Damage to marine ecosystems

- Mechanical damage to some coral reefs- eg; Hikkaduwa, Unawatuna etc. and other marine fauna
- Debris and sand deposition on reef
- Where they still existed after years of mining, blastfishing and bleaching, intact coral reefs acted as buffers to the waves

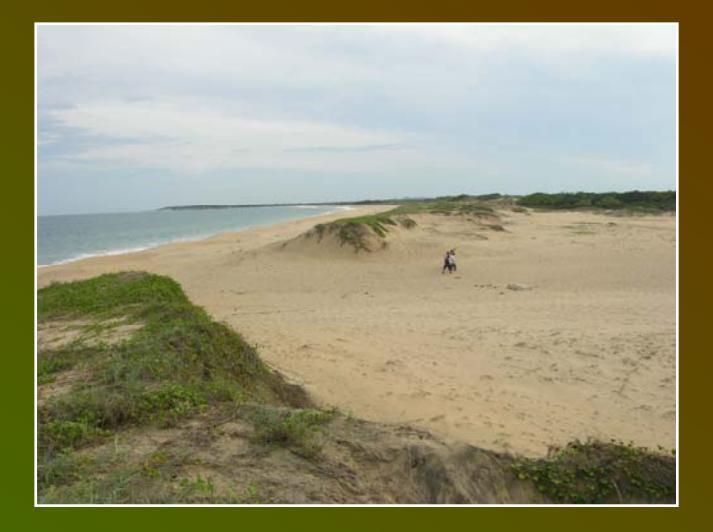
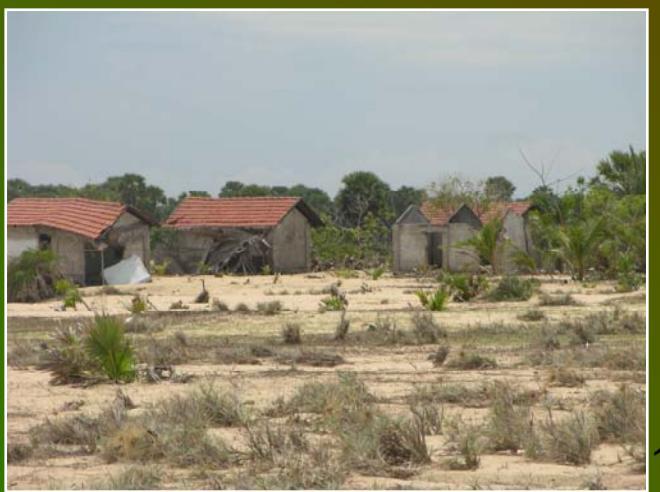
Damage to shoreline ecosystems

- Sand dunes prevented wave damages drastically but in few places where there is modification by human intervention there was a breach of sand dune causing devastation – eg: Panama, Bundala
- Erosion or deposition of sand in beaches
- Destruction of other types of vegetation in the shoreline – eg: Karthivu

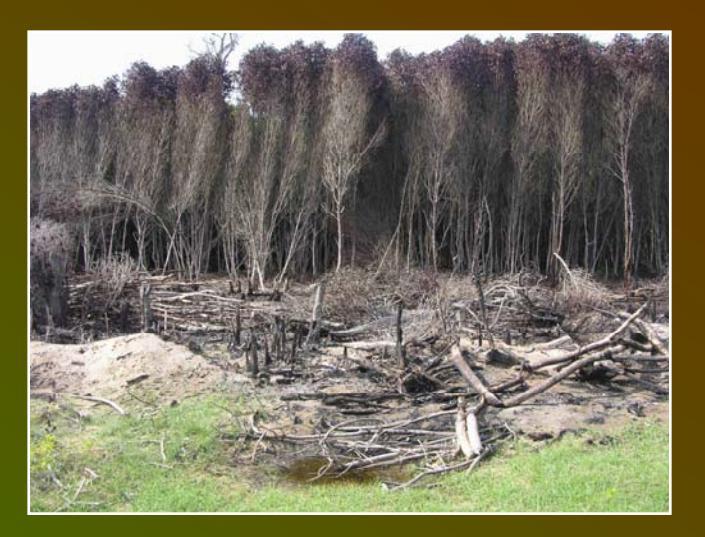
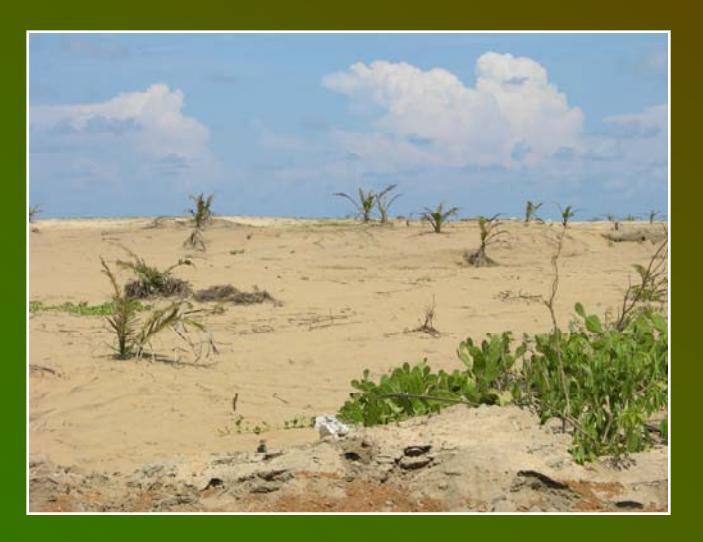
Damage to inland ecosystems

- Frontline mangroves damaged but acted as a good shield – eg: Rakewa
- Destruction to vegetation such as Pandanus (Wetakeyia), palmyrah trees and some of the less saline tolerant plants
- Destruction to crops having economic value such as banana, *Casuarina (Kasa)* etc.
- Alien species of cactus spread in some areas (eg. Bundala Sanctuary)
- Little risk of bioaccumulation in coastal fauna

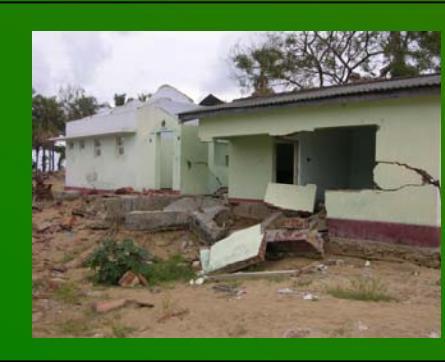
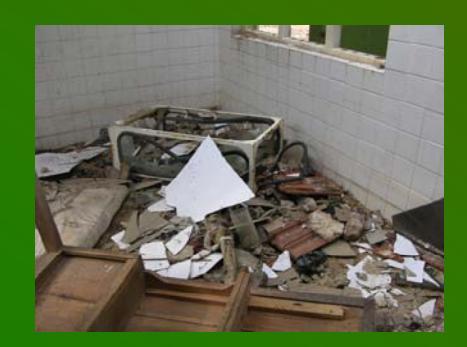
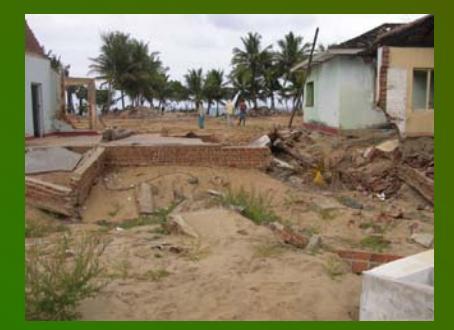
Project : Debris clearing in Karthivu

- Damaged hospital, school and other infrastructure
- Resulted in a mixture of debris in many areas

- Identify an area in which solid wastes could be dumped
- Minimize the dumping material with an encouragement of reuse and recycle
- Dump non-hazardous material in the proposed area in an environmental sustainable manner
- Encourage the reuse of hospital wastes as practical as possible
- Disinfect with Chlorination the remaining hospital wastes
- Dump the disinfected hospital waste in the dump yard

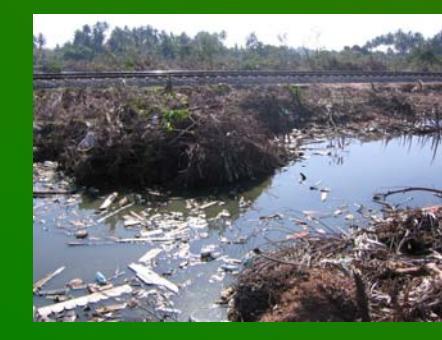
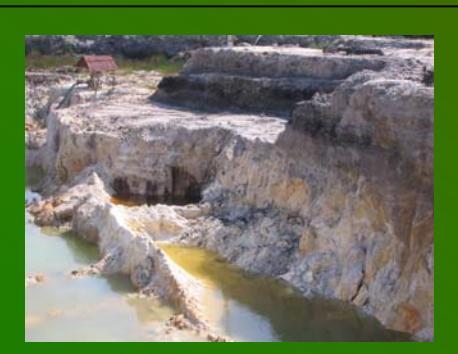
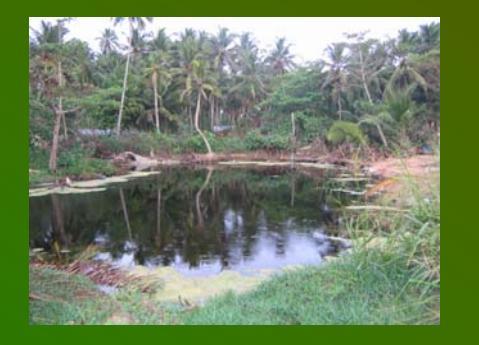
Project : Restoration of abandoned or ongoing mineral pits in Akurala, Telwatta, Hikkaduwa, Habaraduwa and Ambalangoda

- Haphazard dumping of debris
- Ideal habitat for mosquito breeding and other disease causing organisms
- Pollution could be on the rise
- Visual pollution is apparent

- Find out whether these areas are flood retention areas
- If yes, dredge and clean the areas
- If not, reclaim properly for utilization
- If the water remains, clean it and plan for any other beneficial use such as aquaculture or recreational activities etc.
